Rhino Rails, LLC 105 Thackston Rd. Duncan, SC 29334

As requested, I am providing a summary of the guard rail tests I observed at your facility on March 26, 2010. The purpose of the test was to confirm the impact rating of Rhino Rails's guard rail system – both of the existing design and for a new design being considered. The system is rated to withstand an impact of 10,000 pounds at 4 miles per hour.

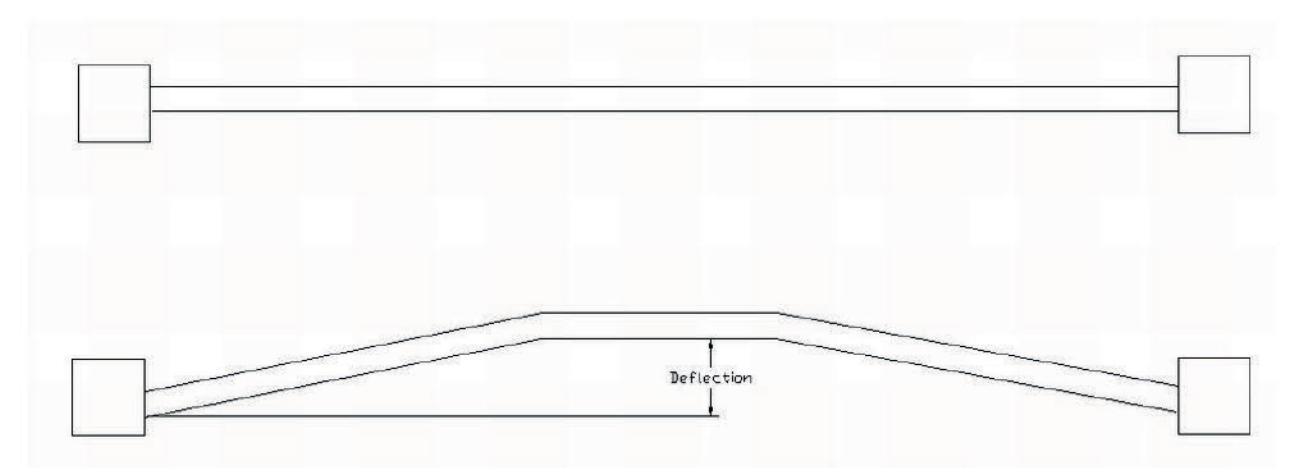
Sketch of guard rail before and after impact (Deflections are specified in report)

Two tests were observed. For the first test the support posts were constructed with the current design support posts. During the first test the guard rail remain attached to the support posts during impact. The guard rails deflected approximately 12 inches at its center during the impact. It was determined, using the video recording, that the speed of the fork truck at the time of impact was approximately 6 miles per hour.

For the second test the support posts were constructed with the new design support posts. During the second test the guard rail remain attached to the support posts during impact. The guard rails deflected approximately 13.5 inches at its center during the impact. It was determined, using the video recording, that the speed of the fork truck at the time of impact was approximately 5.5 miles per hour.

The attached sketch shows the guard rail before and after the impact.
